DEPARTMENT OF THE ARMY  
U.S. ARMY ENGINEER DISTRICT, ALASKA  
P.O. BOX 6898  
JOINT BASE ELMENDORF RICHARDSON, ALASKA 99506-0898

The purpose of this letter is to notify your office of a federal undertaking with the potential to affect historic properties and to seek your concurrence on the assessment of effect for the proposed project.

### **Denali Commission Mooring Points Project, Phase 4: Kiana Archaeological Survey**

### **Denali Commission Mooring Points Project, Phase 4: Noorvik Archaeological Survey**

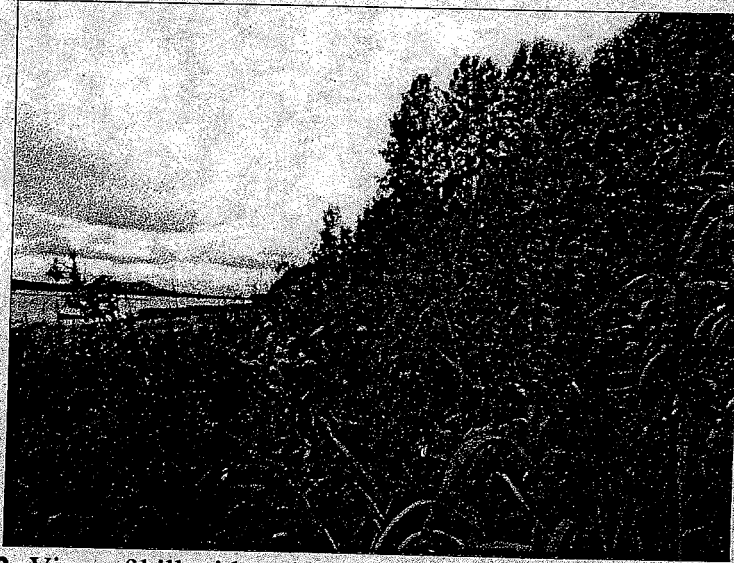
Pedestrian surveys of the second and third areas found three large gravel pads sticking out into the river at the base of a steep hill (see Fig. 2). A small surface scatter of fish bones and fragmentary mammal vertebrae was located along the base of the hill, as well as numerous pieces of modern trash. Four shovel test pits were sunk in along the base of the hill at the potential mooring points:

**Figure 2:** View of hill with stabilization posts from Test Pit 3 at Area 2/3

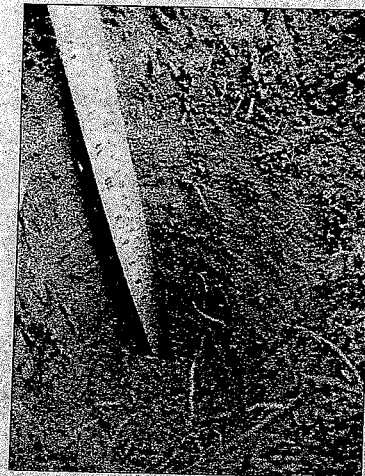
Test Pit 2: N66°58.436  
W160°25.366'

All test pits were excavated to 50 centimeters below surface, and yielded a mixture of cultural materials of primarily modern nature, including animal bones, glass shards, metal wire, nails, tinfoil, foam, and cut wood (see Figs. 3-5). Informants from the village noted that the houses at the top of the hill were built in the 1970s, and that before it was stabilized in 1991, the hillside was non-vegetated. Informants also noted that the seasonal high water mark for the river is at the base of the hill. Between the erosion of the hillside and accretion from sediments carried in the river, the cultural materials found at the base of the hill are located in a discontinuous hodgepodge of depositional events. Any potentially historic material could not be differentiated from modern material. No cultural resource features were identified in either of the two potential mooring point areas.

**Figure 4:** Shovel Test Pit 2 at Area 2/3

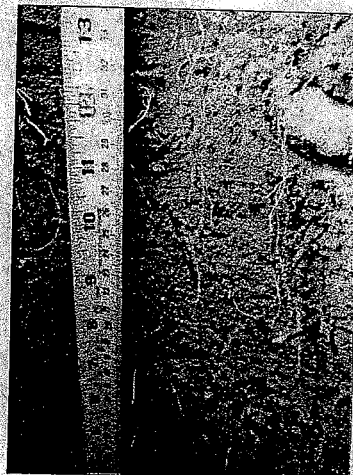
Test Pit 4: N66°58.421'  
W160°25.411'

**Figure 5:** Test Pit 4 at Area 2/3

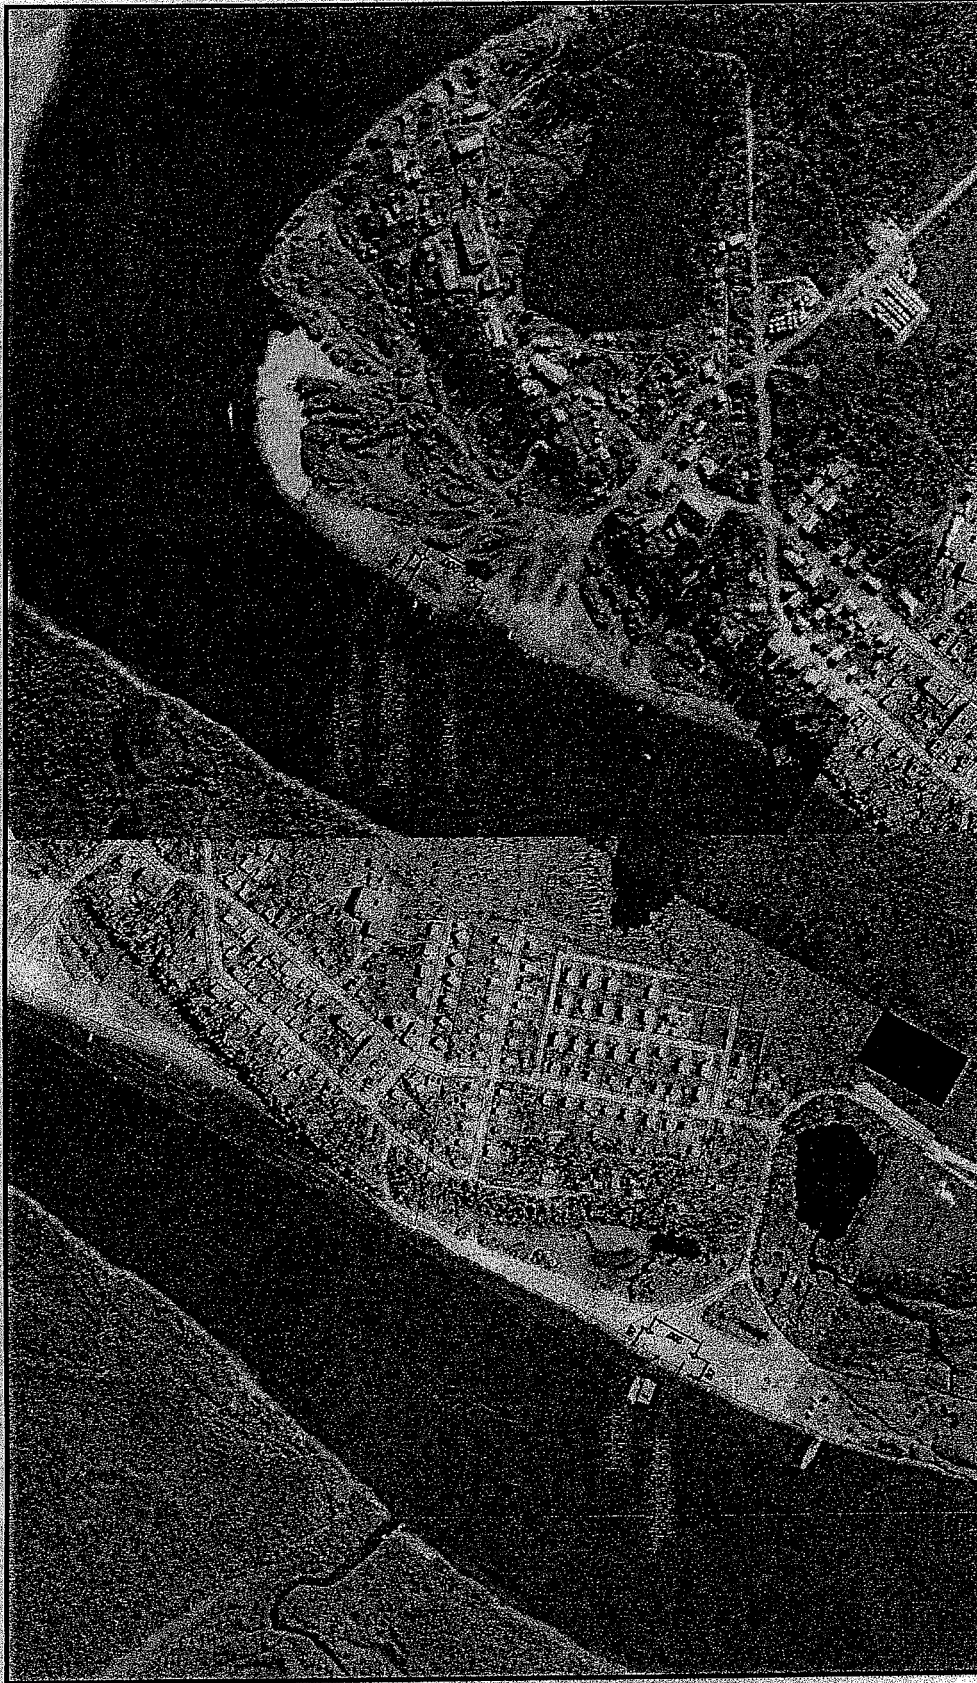
NOORVIK PROPOSED MOORING POINT LOCATIONS  
DENALI COMMISSION MOORING POINTS PROJECT - PHASE 4

Four mooring points will be placed at two existing barge landing locations in Noorvik (Enclosure 12). The APE is composed of two noncontiguous areas. The first area is at the landing site at the north end of the community, on a dynamic beach composed of accreted silts and sands. Willows and grasses are encroaching onto the accreted beach. The second area is at the south end of town, on a large, flat landing composed of gravel fill deposited over accreted silt and fine sand.

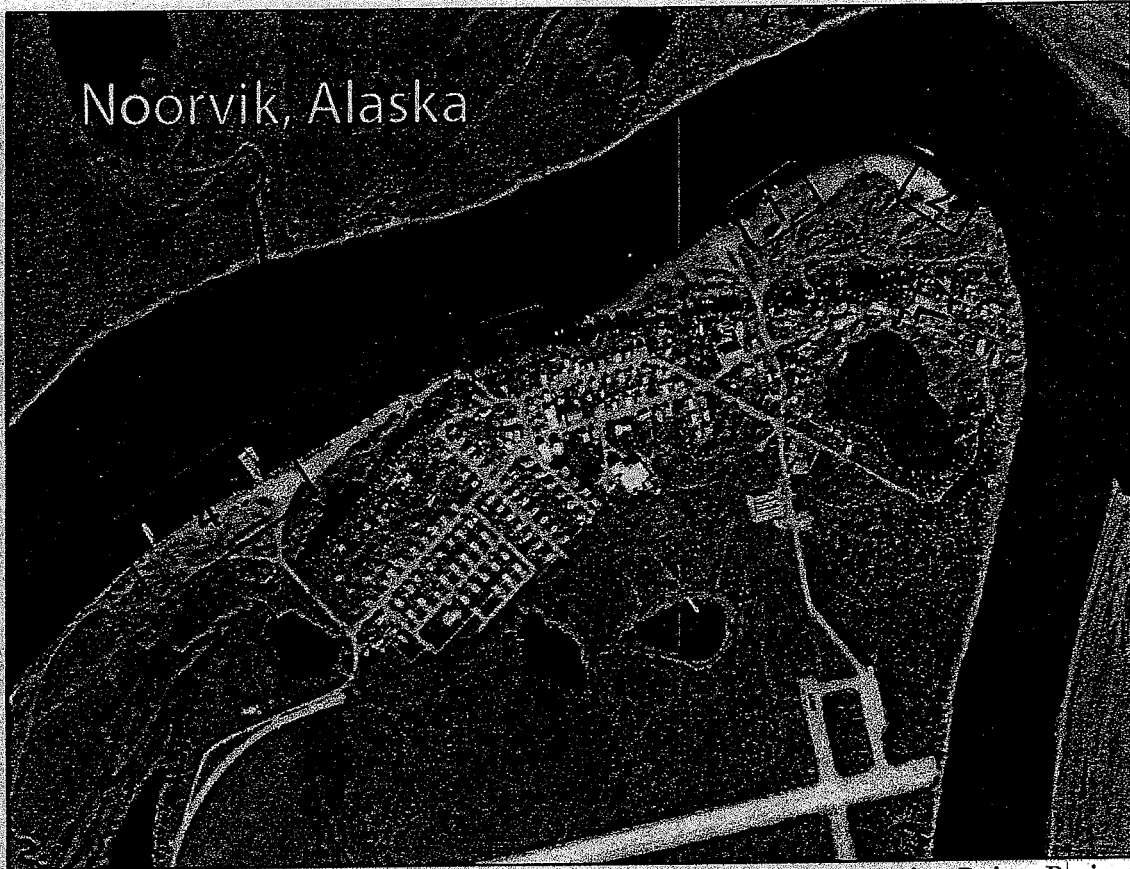
Figure 1: Areas surveyed at Noorvik for the Denali Commission Mooring Points Project

Four potential mooring point locations were inspected (see Fig. 1). Pedestrian surveys at the first and second locations found that they were composed entirely of accreted silt that was slowly being colonized by shrub alder, shrub willow, and grasses. Shovel test pits sunk in at the four potential mooring points (about 75 feet inland from the eroding riverbank) displayed stratified silt (see Fig. 2).

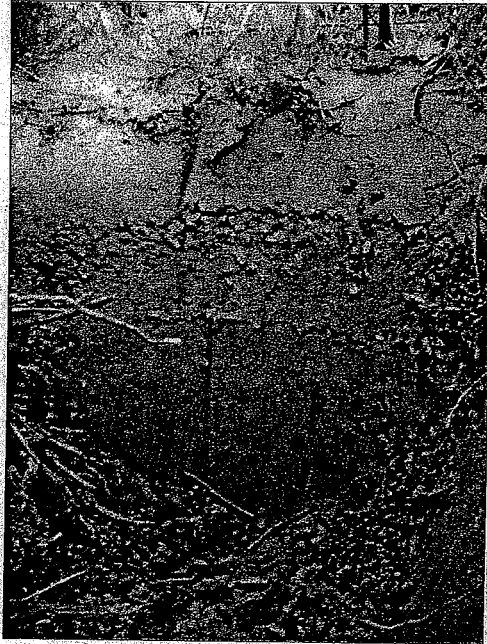
**Figure 2: Shovel Test Pit at Area 1**
